INDOOR AIR QUALITY ASSESSMENT

Related to Sewer Gas Odors in Selected Areas

**J. C. Solomonese Elementary School
315 West Main Street
Norton, Massachusetts**

Prepared by:
Massachusetts Department of Public Health
Bureau of Environmental Health Assessment
May, 2001

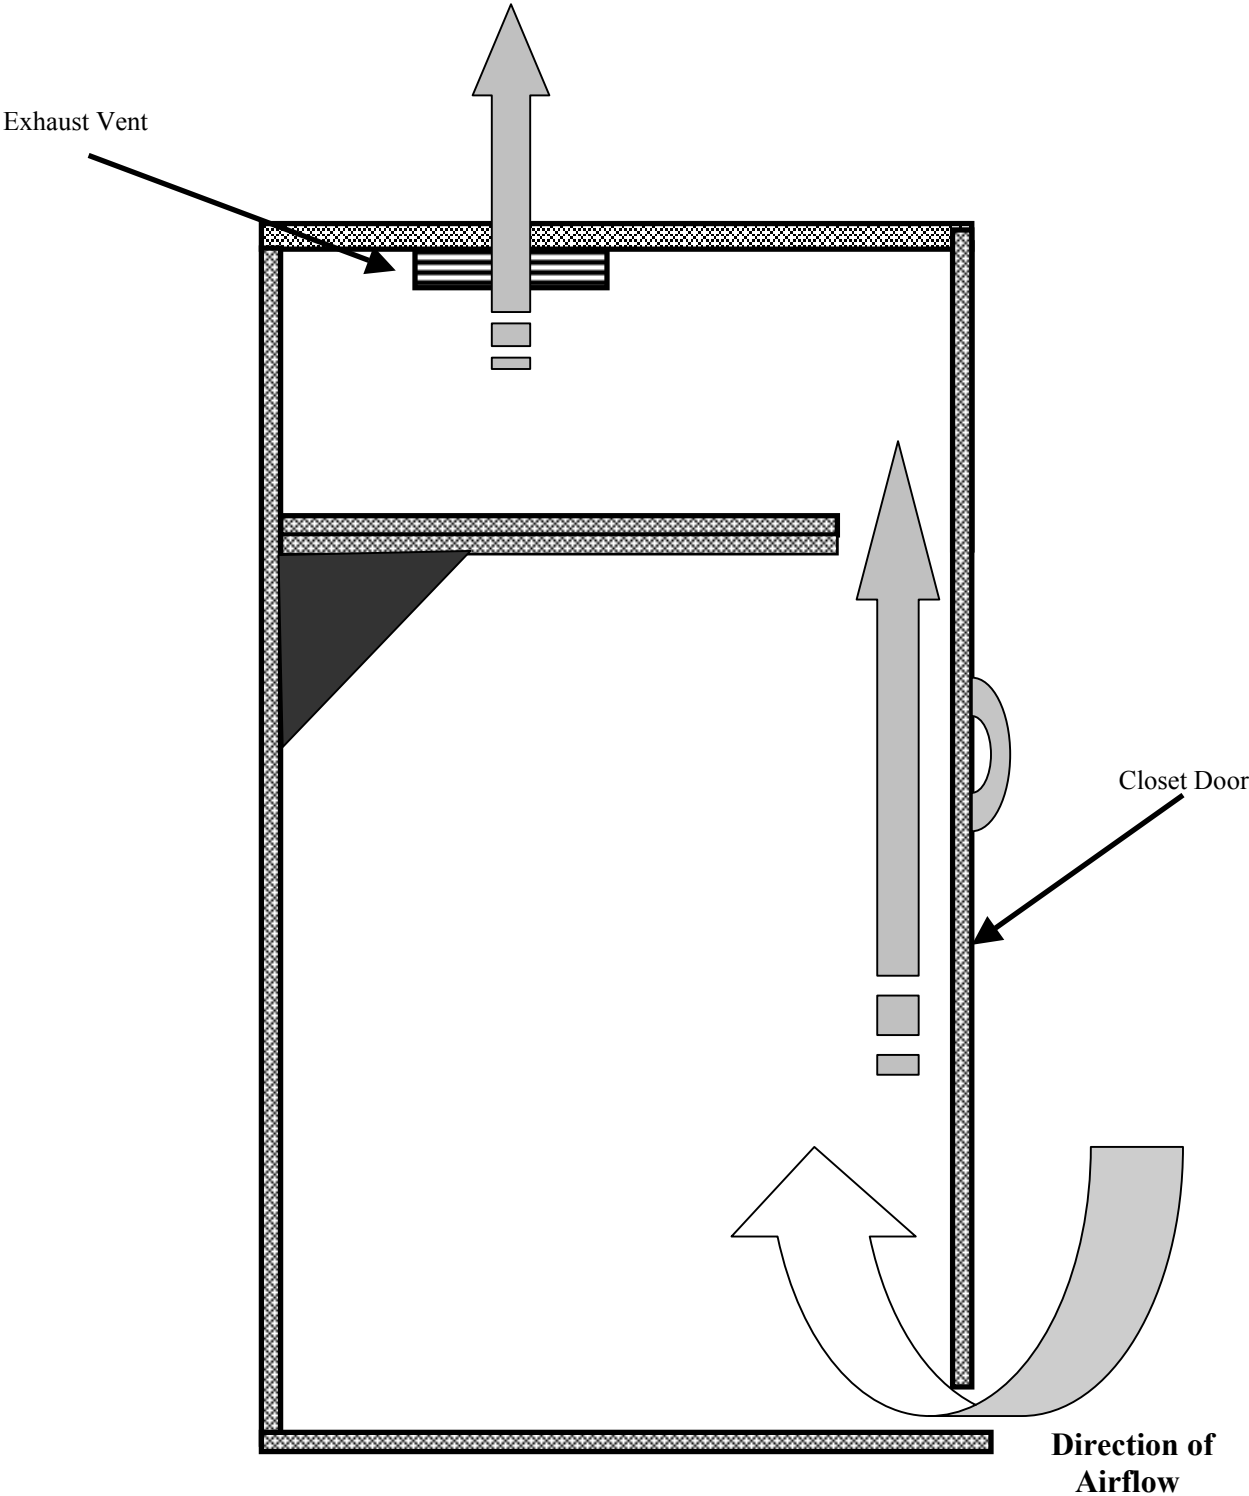
Figure 1:

1. General exhaust ventilation in this classroom is provided by a vent located in the upper portions of a storage closet (Picture 1). It appears that classroom air is drawn through a space beneath the closet door (see Figure 1). This design allows for the vent to be easily blocked by stored materials (see Figure 2/ Picture 2). In addition, the space beneath the door appears to be insufficient for the draw of exhaust air from the classroom.
2. A unit ventilator provides fresh air for this classroom. Above the fresh air diffuser is a passive vent installed in the ceiling (see Picture 3). This passive vent opens into the ceiling plenum for no discernable purpose. As the univent

**Designed Configuration of Airflow into the Closet Exhaust Vent
(Side View)**

6. Remove stored materials blocking the beneath-the-door space of the storage closet in room 20. Examine the feasibility of: increasing the space beneath the closet door, installing a passive door vent or moving the exhaust vent from the ceiling of the closet to the wall above the closet door.

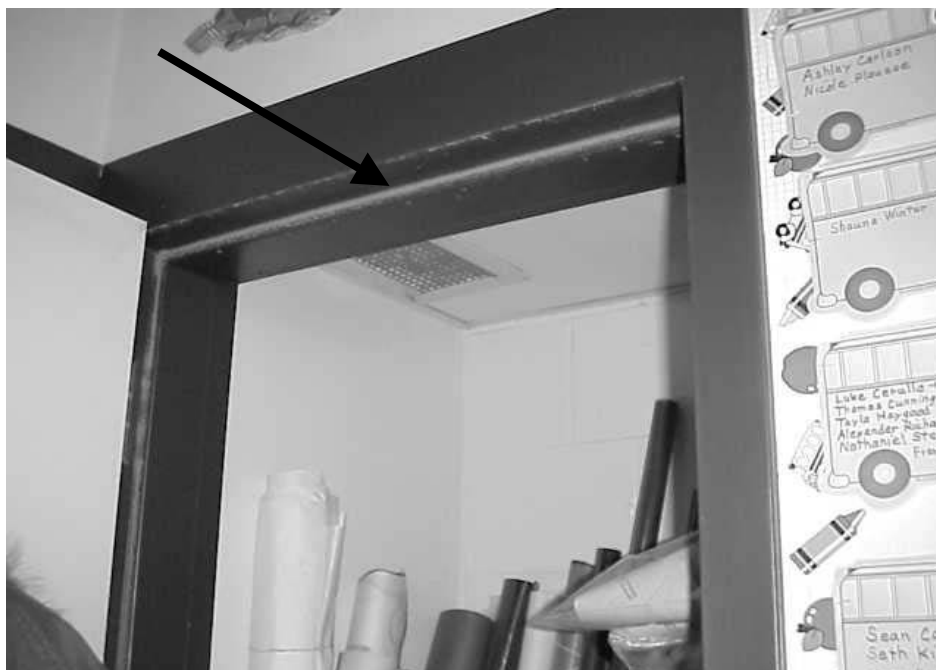
Picture 1

Room 20 Exhaust Vent in Closet, Note Heavy Coat of Dust on the Door Frame, Which Indicates Airflow into the Closet through the Doorframe

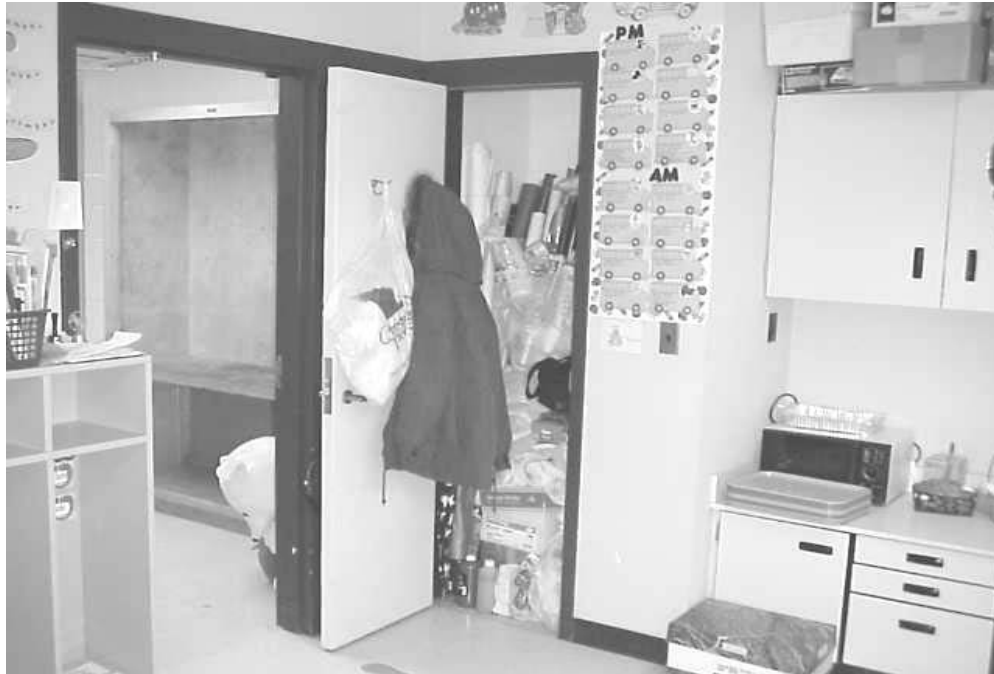
Picture 2

Bottom of Closet Door Blocked with Stored Materials in Room 20

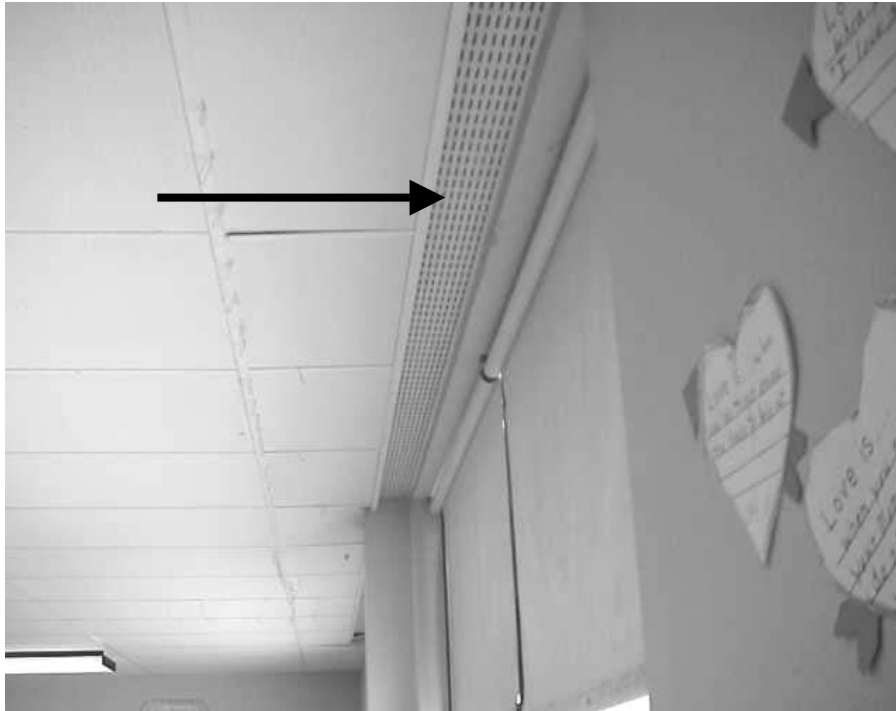
Picture 3

operates, air is forced up into the ceiling plenum through this passive vent. This can result in the creation of positive pressure of the ceiling cavity, which can result in air moving from the ceiling cavity back into the classroom. A positively pressurized ceiling plenum can result in dust, dirt and other pollutants being forced through the ceiling plenum into the classroom.

Passive Ceiling Vent over Room 20 Unit Ventilator

7. Replace the ceiling mounted grate above the room 20 univent with a ceiling tile.
8. Continue to routinely pour water into the floor drain of the penthouse.

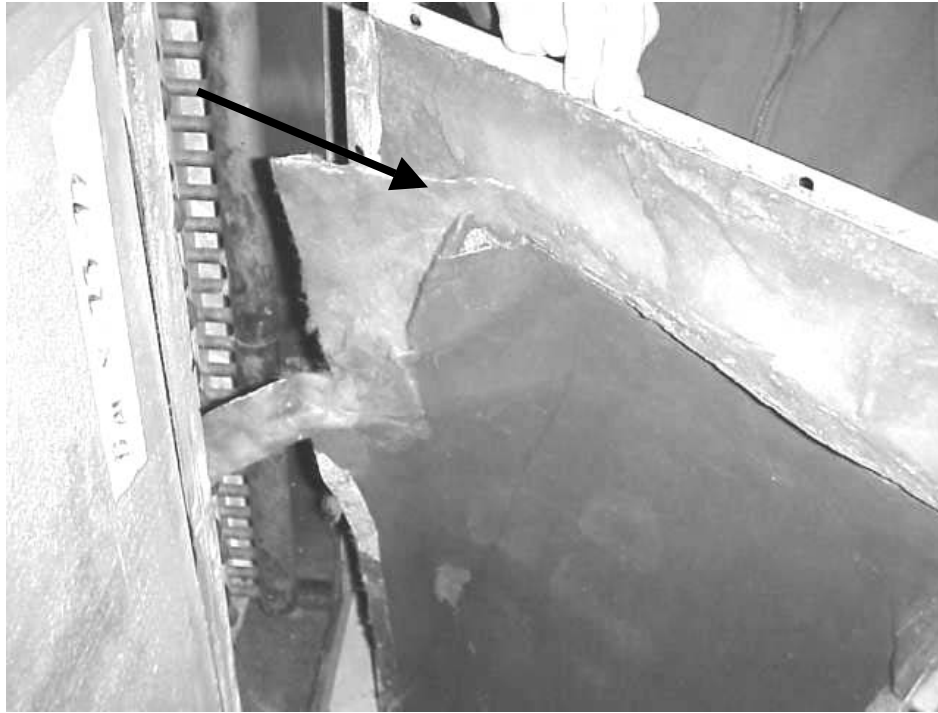
Picture 4

The interior of the penthouse AHU was evaluated while operating during cool weather. Since this AHU has air-conditioning capacity, the use of the ventilation during warm weather can result in the generation of condensation. As outdoor air is drawn over cooling coils in the AHU, moisture in the form of condensation is generated. As condensation collects, water droplets are formed which drip from the cooling coils. Condensation is collected in drip pans beneath the cooling coils. Drip pans direct collected water from the AHU into a floor drain in the penthouse. The surface of the drip pan and AHU casing appeared to be severely corroded. Cooling coil fins were corroded near the base of the unit, accompanied by scale and debris. The floor of the AHU also appeared to be coated with accumulated dirt and debris. Insulation installed on the interior surface of the AHU casing was found torn and degrading (see Picture 4).

Standing water in drip pans, moistened debris on the floor of the AHU and repeatedly wetted insulation can all serve as growth media for mold. If mold growth occurs, spores and odors can be transported into the interior of the building via the heating, ventilating and air-conditioning (HVAC) system.

Torn Insulation on AHU Access Lid

9. Clean accumulated debris from the floor of the AHU cabinet. Consider having the coils cleaned by an HVAC contractor. Remove and replace abraded fiberglass insulation on the interior of the AHU.

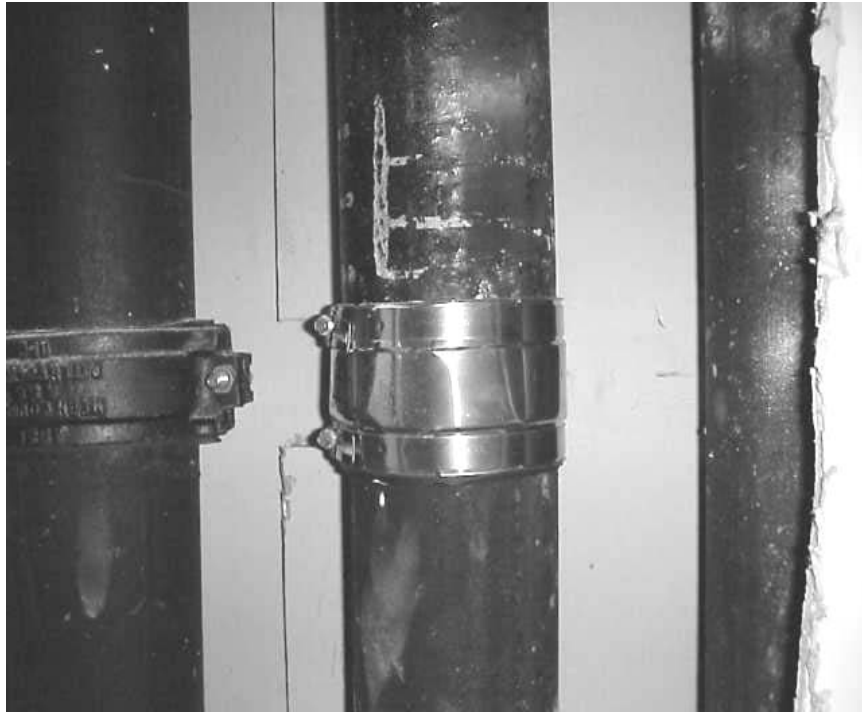
Picture 5

A second means for sewer gas odors was also identified. Sewer gas odors were noted around the vent pipes, which appeared to be enhanced once all kitchen faucets were running. The replaced vent pipe was joined to the floor pipe by a rubber-lined metal collar (see Picture 5). The newly installed steel pipe appeared to be slightly off-line with the floor pipe. This mismatched alignment resulted in bending the rubber-lined clamp, creating a space to the interior of the vent pipe. Drafting air from the pipe collar was visually confirmed by dropping flour along the exterior of the pipe. Flour was seen moving away from the bottom edge of the pipe collar, indicating air movement from the pipe.

Contributing to this air movement is the operation of the kitchen exhaust vent hood. The center of the kitchen has a large, operational exhaust vent hood, which creates negative pressure to draw cooking odors, heat and other pollutants out of the kitchen. Negative air pressure created by the vent hood also draws air from areas surrounding the kitchen. With the integrity of the sewer vent pipe compromised, the operation of the kitchen exhaust vent hood can draw sewer gas odors into the kitchen area. The operation of the kitchen exhaust vent hood can also enhance the draw of backdrafting air through the disabled exhaust vent in the kitchen storeroom.

Metal Collar Connecting Sewer Vent Pipes

1. Reseal/replace the sewer vent in the kitchen storeroom to render this pipe airtight. [This activity was reported to be completed (NPS, 2001)].
2. Extend the kitchen sewer vent pipes in a manner similar to the sewer vent pipes on the western side of the two-story wing roof. [This activity is planned (NPS, 2001)].
3. Repair the kitchen storeroom exhaust vent and operate during school hours.
4. As suggested by school custodial staff, seal the base of kindergarten toilets with a sealant to provide an airtight seal.

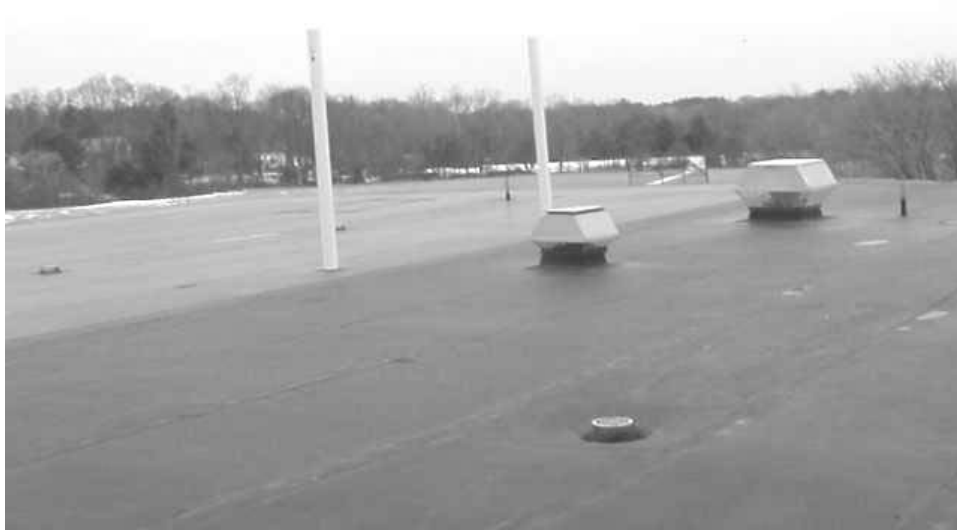
Picture 6

School staff indicated that the two-story wing had experienced sewer gas odors previously, presumably from AHU entrainment from rooftop sewer vent pipes. Efforts to prevent sewer gas odor included extending sewer vents to the west of the penthouse with PVC pipe (see Picture 6) and sealing sewer vents to the north of the fresh air intake of the penthouse AHU. The most likely source of sewer odor entrainment is the condensation drain of the AHU. The mechanical room penthouse contains an AHU that services the interior classrooms of the two-story wing. This AHU is equipped to provide air-

Extended Sewer Vent Pipes on Western Section of the Two-Story Wing Roof

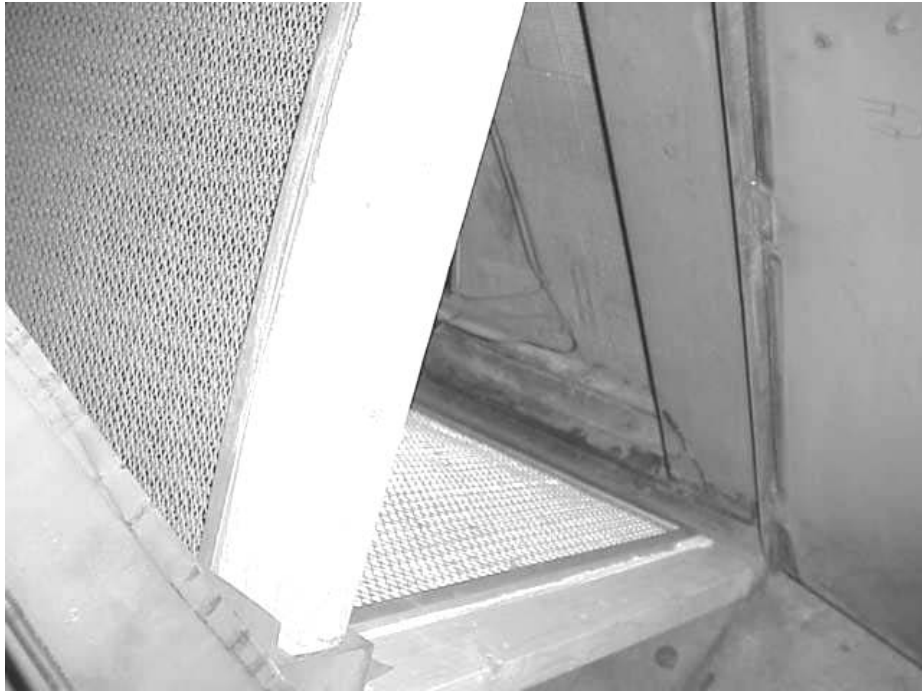
Picture 7

The penthouse AHU has wire mesh installed as filters (see Picture 7). These wire mesh screens are designed to prevent large objects from entering the AHU chamber and fans and do not filter respirable dusts from the air stream drawn into each AHU. This can result in dust, dirt and other debris being distributed by the ventilation system. AHUs are normally equipped with filters that strain particulates from airflow. In order to decrease

aerosolized particulates, disposable filters with an increased dust spot efficiency can be installed. The dust spot efficiency is the ability of a filter to remove particulates of a certain diameter from air passing through the filter. Filters that have been determined by ASHRAE to meet its standard for a dust spot efficiency of a minimum of 40 percent would be sufficient to reduce airborne particulates (Thornburg, D., 2000; MEHRC, 1997; ASHRAE, 1992). Note that increased filtration can reduce airflow produced by the AHU by increased resistance. Prior to any increase of filtration, the AHU should be evaluated by a ventilation engineer to ascertain whether it can maintain function with more efficient filters.

Wire Mesh Screens in the Penthouse AHU

10. Consider removing the unused humidification equipment from the AHU ductwork.
11. Consider replacing wire mesh screens on the penthouse AHU with filters that have an increased dust spot efficiency to remove particles from the air stream.
